PIPE REPAIR BANDAGE

CASE STUDIES

LIST OF CASE STUDIES

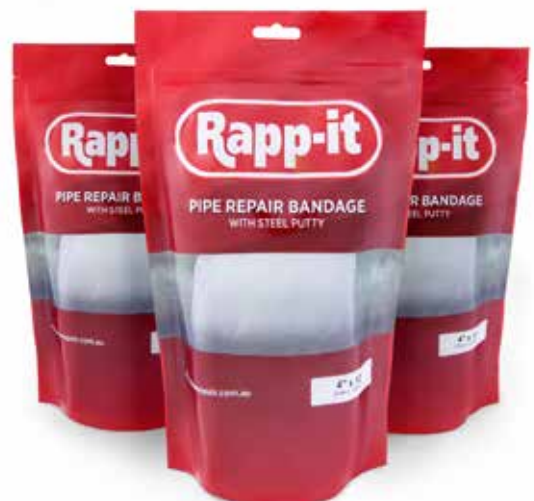
STEP 1: Shut down pipes or hoses. Apply gloves, then thoroughly clean and roughen the damaged pipe area. A clean, rough surface helps result in a successful repair.

STEP 2: Knead Steel Putty and apply firmly into the damaged area. Putty has a 2-5 minute work time, and the bandage application must begin during this time.

STEP 3: Soak bandage in fresh water for 10 seconds. Squeeze bandage 1–2 times while in water to help activation.

STEP 4: Quickly wrap the bandage around the damaged area, extending 50mm either side of the leak. Pull firmly throughout application. **A strong, tight repair is very important.**

STEP 5: With wet gloves, squeeze the bandage with a rotating motion until resin stops foaming and is set. Allow a minimum of 30 minutes for Rapp-it Bandage to set rock-hard. For best results, ensure bandage application is at least 10mm thick.

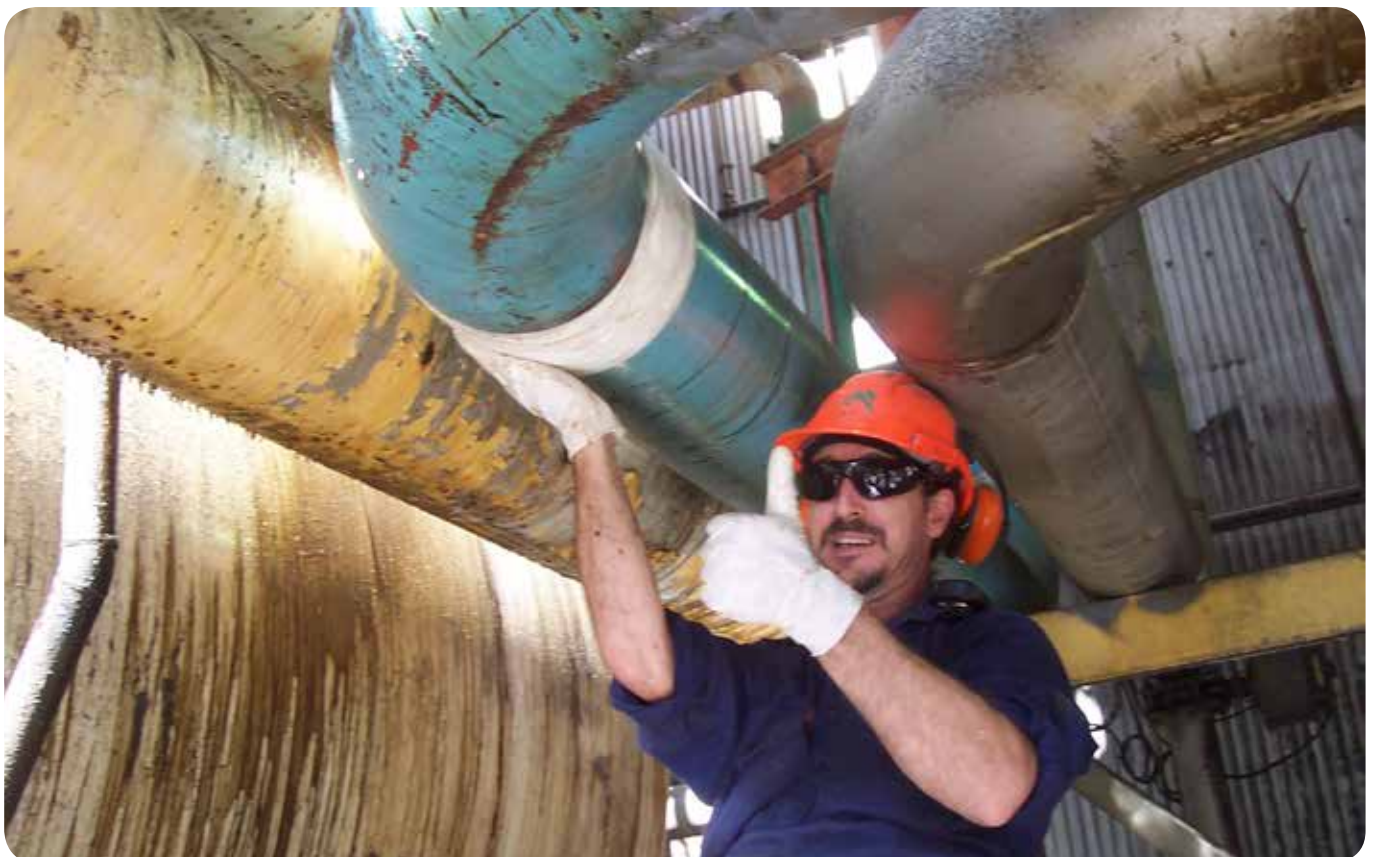
HYDROELECTRIC POWER STATION CASE STUDY

The customer advised that they had an overhead leak in a 100mm water main line. The pipe required urgent repair, as the damaged area was dangerously close to electrical conduits which was creating a safety hazard.

The customer reduced the line pressure and then cleaned and roughened the damaged area. The leak was plugged with Rapp-it Steel Putty and Rapp-it Pipe Repair Bandages (100mm x 4.8m) were applied over the top. The line was fully functional 30 minutes after application.

Pipe Substrate	Steel
Pipe Contents	Water
Internal Pressure (psi)	116 psi / 800 kPa
Temperature (°C)	7°C – 15°C
Pipe Diameter (mm)	100mm
Damaged Area (mm)	180mm

“We recently applied the Rapp-It bandage repair kit to a leaking 4-inch water main pipe. Upon return to service of the pipe, no leakage was detected, and the water main line has remained in service allowing us to now long-term budget plan replacement of this section instead of an unplanned budget cost and replacement.”

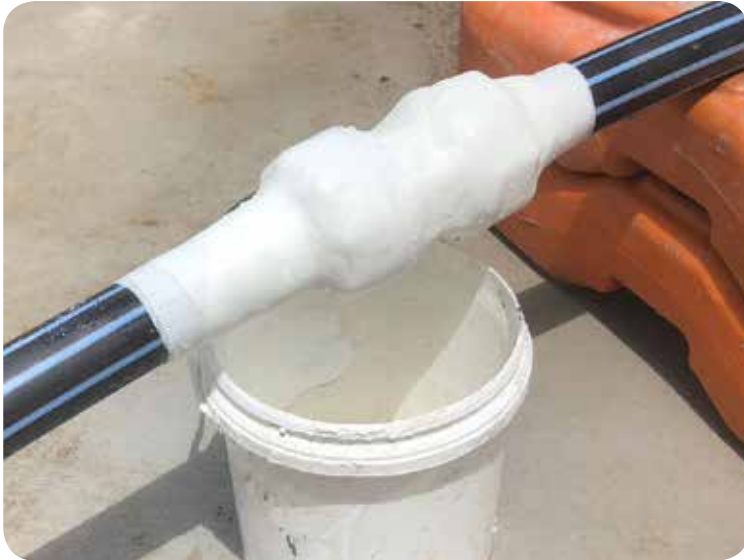
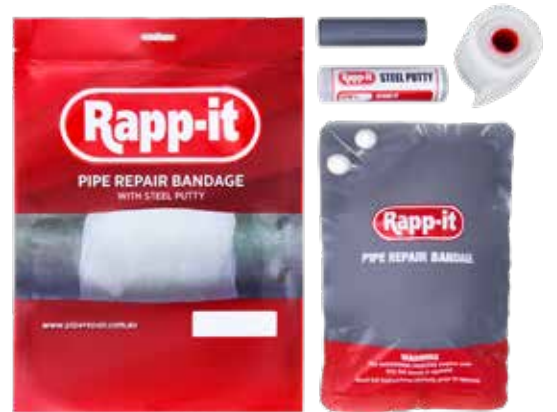
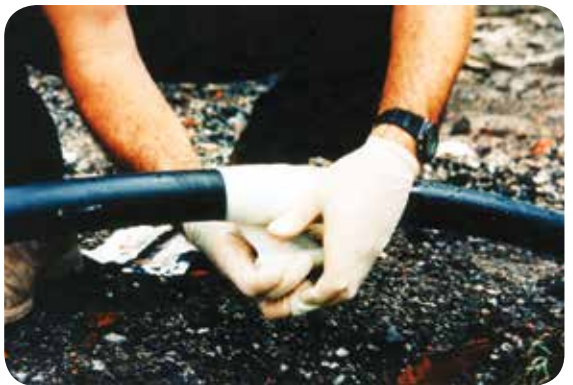
CONSTRUCTION SITE CASE STUDY

The customer advised that they had a leak on a poly pipe water line feeding the job site. The pipe could not be shut down and required an urgent temporary repair, as the water spillage on the ground was creating a safety hazard for construction workers accessing the area.

The customer decreased the line pressure and then cleaned the area. As the leak was located close to a poly joiner it was advised that Rapp-it be applied over the joiner to ensure the leak would be fully contained. Using Rapp-it Steel Putty and a Rapp-it Pipe Repair Bandage (100mm x 3.6m) applied over the joiner, the leak was successfully contained within 30 minutes with no further spillage onsite.

Pipe Substrate	Poly Pipe
Pipe Contents	Water
Internal Pressure (psi)	100 psi / 690 kPa
Temperature (°C)	Ambient
Pipe Diameter (mm)	100mm

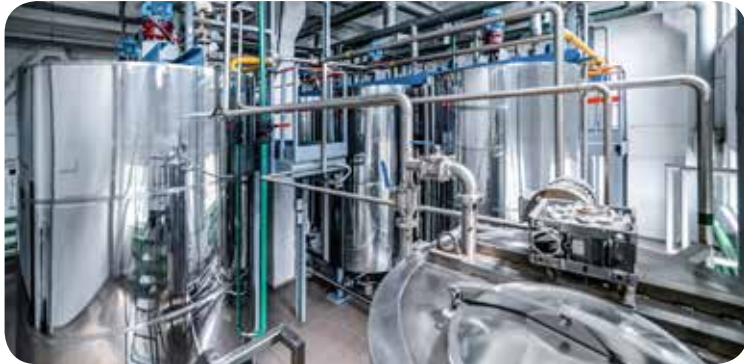
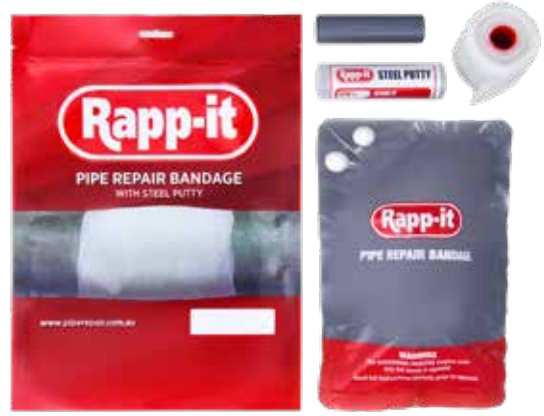
FOOD & BEVERAGE CASE STUDY

The customer advised that they had an overhead leak in a corroded line at 2am in the morning. The pipe required urgent repair, as water spillage on the ground was creating a safety hazard for staff accessing the area.

Pipe Substrate	Steel
Pipe Contents	Water
Internal Pressure (psi)	150 psi / 1034 kPa
Temperature (°C)	Ambient
Pipe Diameter (mm)	250mm
Damaged Area (mm)	180mm

The pressure in the line was reduced and the corroded area was cleaned and roughened. The leak was stemmed with Rapp-it Steel Putty and Rapp-it Pipe Repair Bandages (100mm x 9m) applied over the top. The line was back up running at full capacity 30 minutes after application.

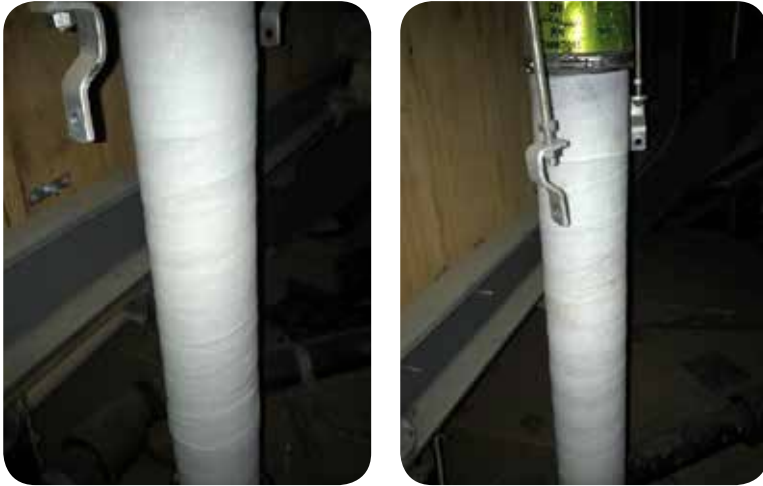
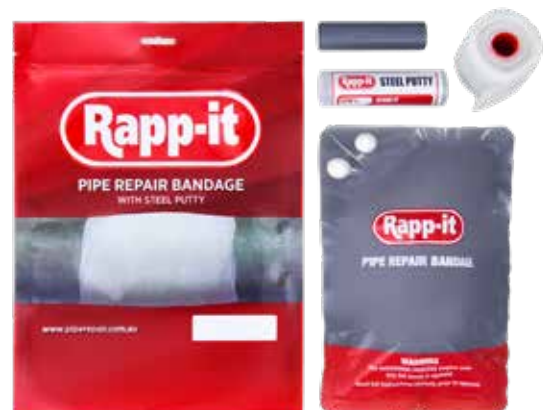
SYDNEY THEATRE CASE STUDY

The customer advised that they had a leak in their 1992 vintage cement storm water run-off pipes. The pipes required urgent repair, as the damaged area was dangerously close to electrical, lighting and costumes. This was creating a safety hazard for all staff and patrons, as well as potentially damaging thousands of dollars' worth of costumes.

Pipe Substrate	Cement
Pipe Contents	Water run off
Internal Pressure (psi)	100 psi / 690 kPa
Temperature (°C)	10°C – 20°C
Pipe Diameter (mm)	100mm
Damaged Area (mm)	20mm

After the customer stemmed the flow of water, cleaned and roughened the pipe, they used Rapp-it Steel Putty and a Rapp-it Pipe Repair Bandage (50mm x 3.6m) to seal the leak. The successful application ensured no risk to staff or patrons, or costume damage.

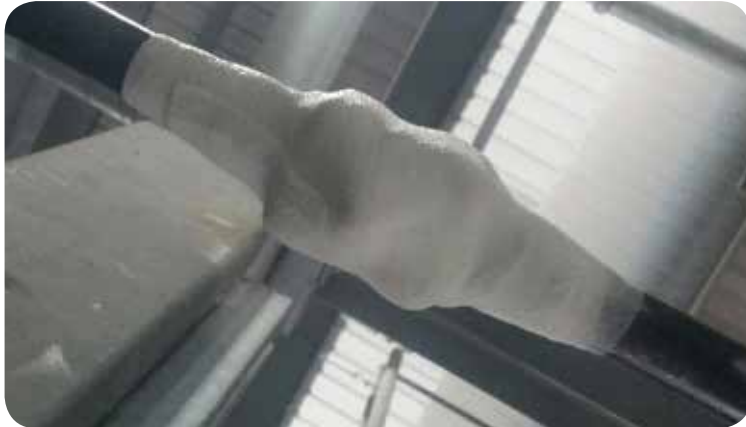
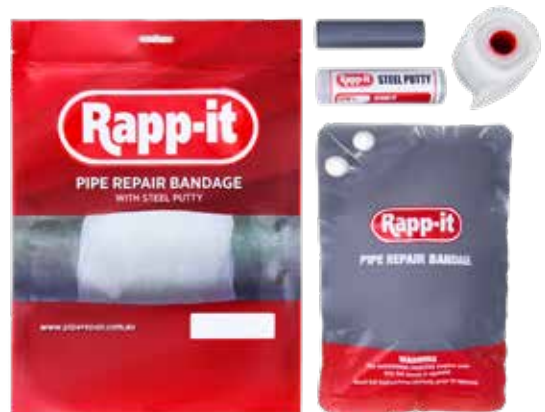
PAINT MANUFACTURING CASE STUDY

The customer advised that they had an overhead leak in a 25mm ball valve line. The valve required urgent repair, as the damaged area was leaking Texanol. Texanol is a widely used toxic liquid found in paint manufacturing.

Pipe Substrate	Steel
Pipe Contents	Texanol
Internal Pressure (psi)	116 psi / 800 kPa
Temperature (°C)	25°C – 30°C
Pipe Diameter (mm)	100mm
Damaged Area (mm)	25mm Ball Valve

The line was shut down and the damaged area was cleaned and roughened. Rapp-it Steel Putty and Rapp-it Pipe Repair Bandages (50mm x 3.6m) were applied over the ball valve line with 5cm tails on each side. The line was up and running at full capacity 30 minutes after application.

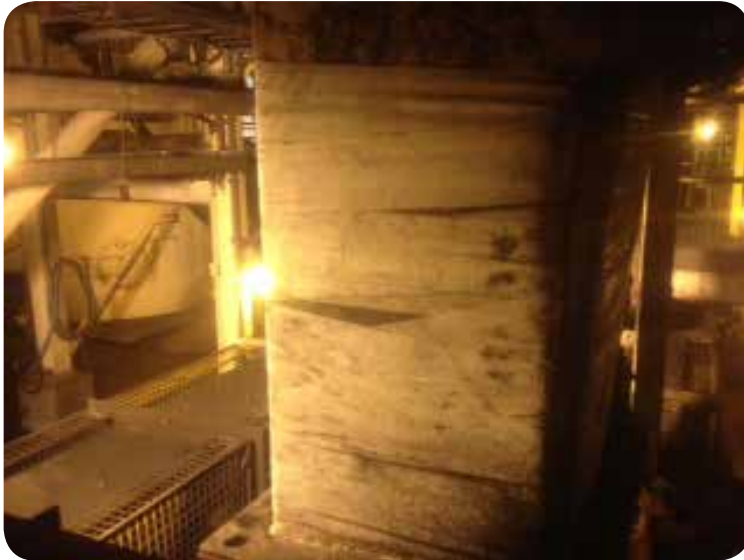
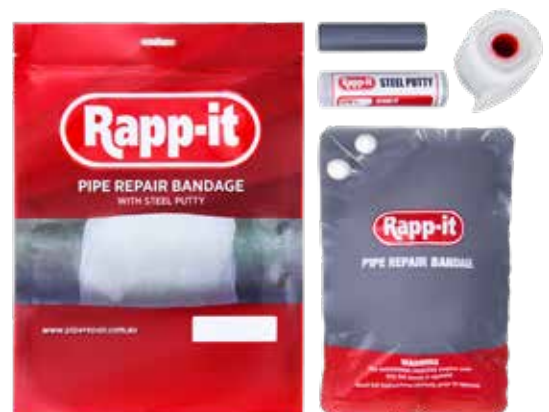
COAL FIRE POWER STATIONS CASE STUDY

The customer advised the coal discharge chute had a leak. The coal discharge chute required a replacement however the power station was unable to stop coal handling processes.

The customer used Rapp-it Steel Putty and applied several Rapp-it Pipe Repair Bandages (100mm x 4.8m) to fix the damaged chute.

Pipe Substrate	Steel
Pipe Contents	Water
Internal Pressure (psi)	87psi
Temperature (°C)	80°C – 140°C
Pipe Diameter (mm)	600mm

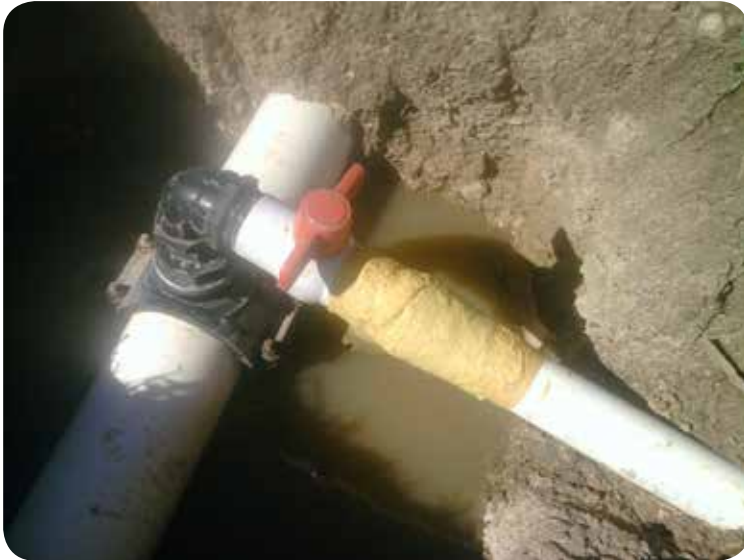
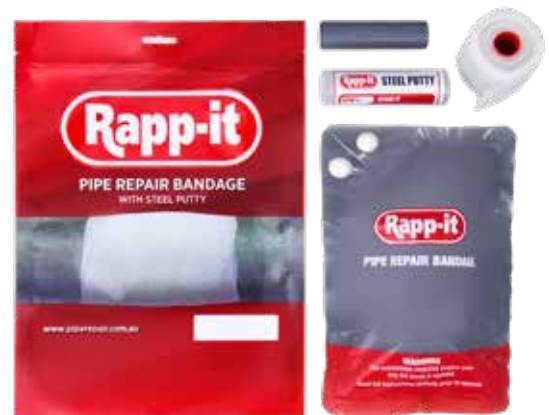
IRRIGATION SYSTEM CASE STUDY

The Customer advised that the glue had failed on a 50mm high pressure union leaving a 35mm long crack. Water was leaking out of the irrigation system causing flooding on the golf course.

The Customer turns off the water to reduce the pressure and isolate the leak. Using the Rapp-it Steel Putty and a Rapp-it Pipe Repair Bandage (100mm x 3.6m) the customer was able to seal the leak. The customer was successful in repairing the damaged pipe without needing to replace the poly pipe.

Pipe Substrate	Poly Pipe
Pipe Contents	Water
Internal Pressure (psi)	87psi / 600kPa
Temperature (°C)	Ambient
Pipe Diameter (mm)	50mm

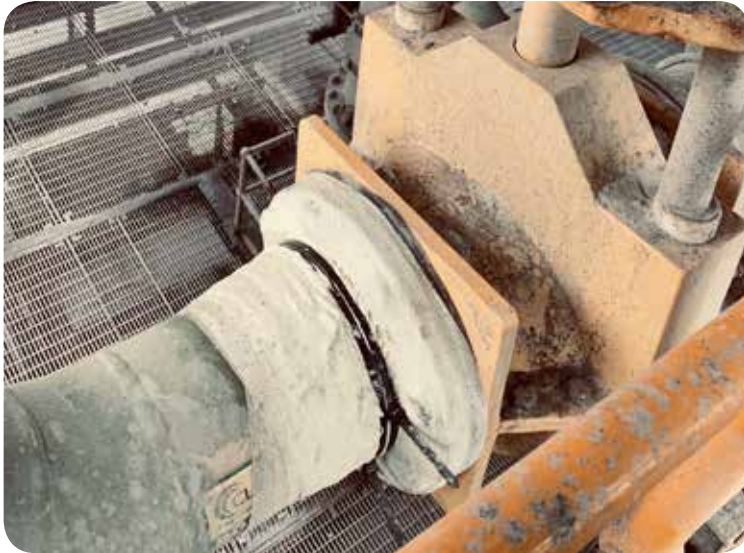
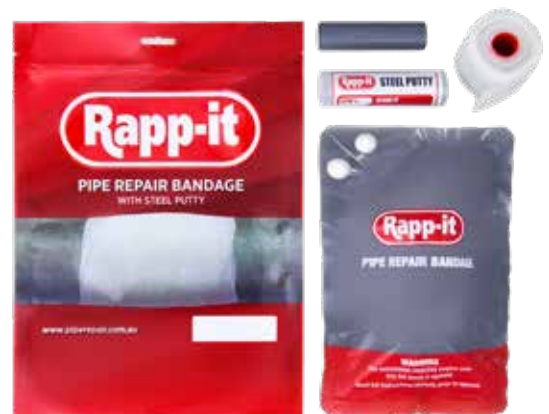
GOLD PROCESSING PLANT CASE STUDY

The customer advised the pipe mainly consisted of water with a small amount of fine ore particles (i.e. gold / copper) that were being sent back to the processing plant after the excess rubbish had been removed. The ore was very abrasive, and a small hole had worn out the pipe before the valve. Shutting down the plant gold plant to replace the pipe would have been costly. Using Rapp-it, the mine could now continue operations until the scheduled maintenance time could be arranged.

The Customer roughened and cleaned the damaged area of the pipe first before applying the Rapp-it Steel Putty over the hole. Then they applied Rapp-it Pipe Repair Bandage (100mm x 9m) to the pipe before the valve. The Customer was successful in repairing the damaged pipe without having to shutdown the processing facility.

Pipe Substrate	Steel
Pipe Contents	Fine ore particles / water
Internal Pressure (psi)	140-160psi
Temperature (°C)	90°C
Pipe Diameter (mm)	150mm

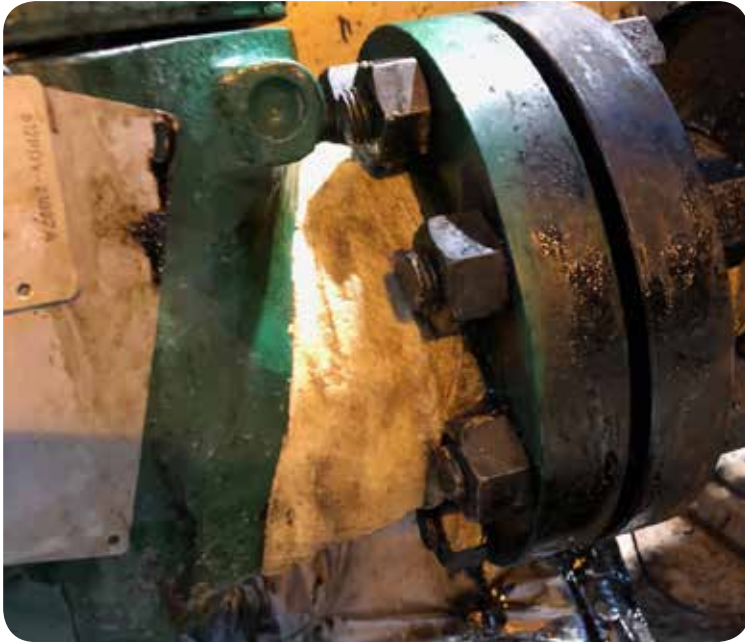
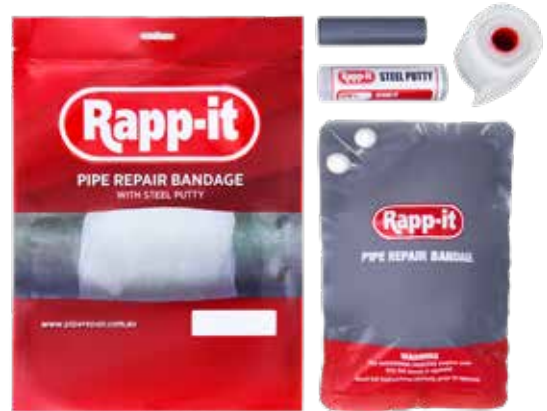
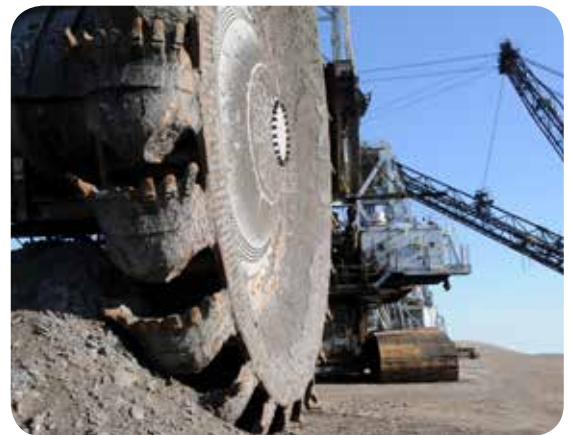
OIL SANDS MINE CASE STUDY

Customer advised they had a rupture on a water line 350mm pipe. The customer’s mine was subject to frigid conditions of -26°C.

The customer shut down the pipe line and then utilised a Herman Nelson heater and sock placed right at the patch location to maintain a moderate temperature. They then cleaned and roughened the damaged area. The leak was stemmed with Rapp-it Steel Putty and Rapp-it Pipe Repair Bandages (100mm x 3.6m) were applied over the top. The line was up and running at full capacity, 30 minutes after application.

Pipe Substrate	Steel
Pipe Contents	Water
Internal Pressure (psi)	87psi/600kPa
Temperature (°C)	Ambient
Pipe Diameter (mm)	350mm

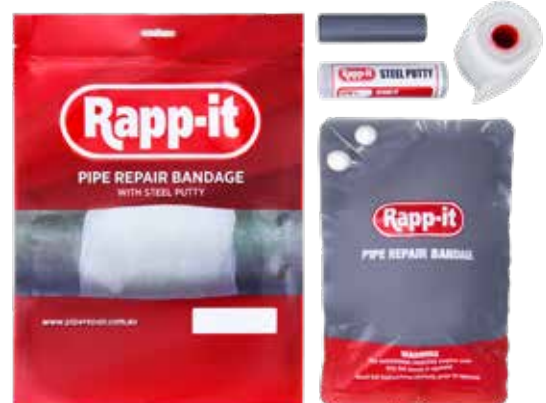
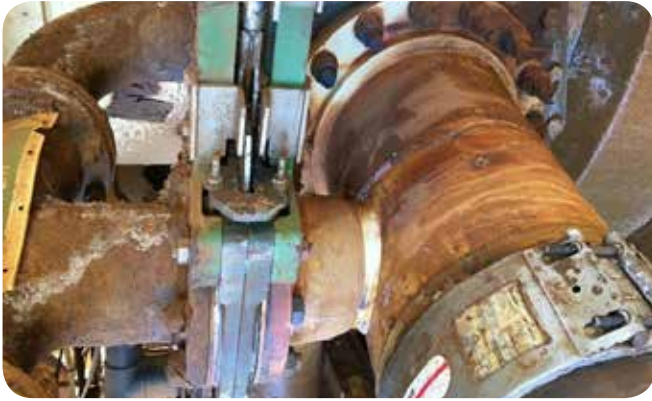
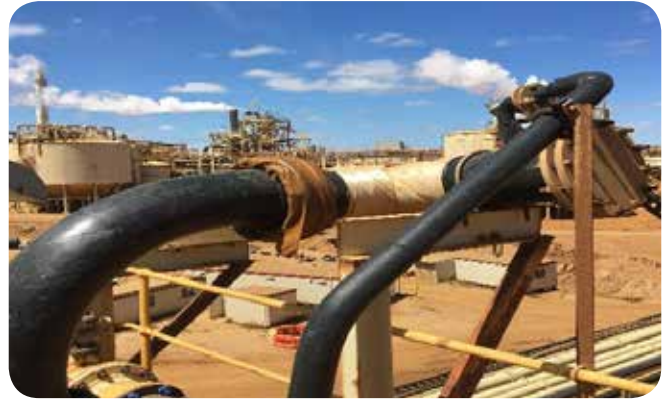
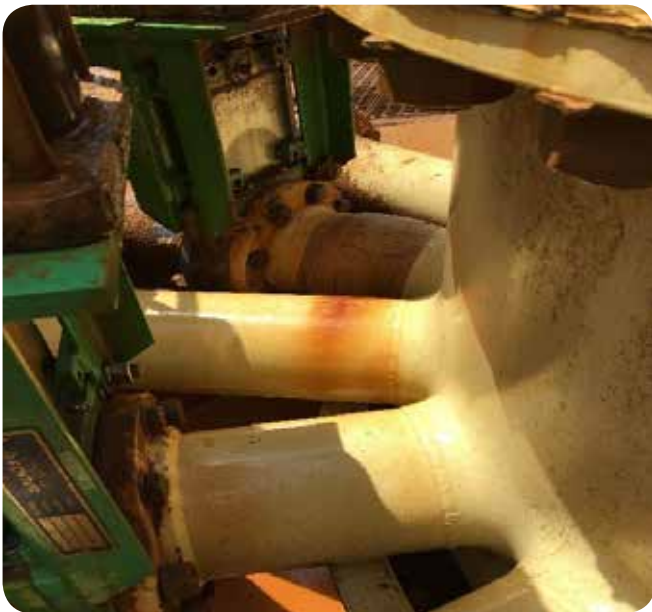
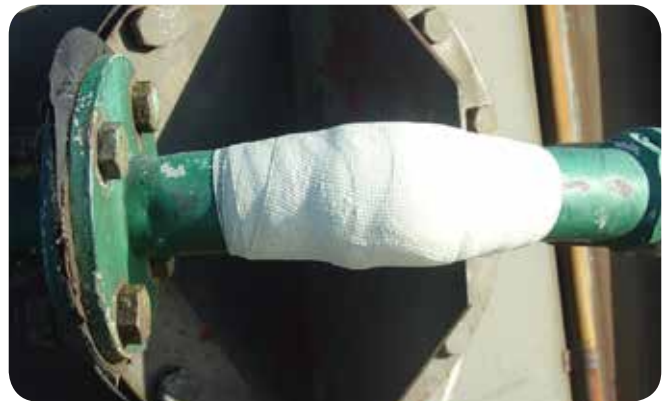
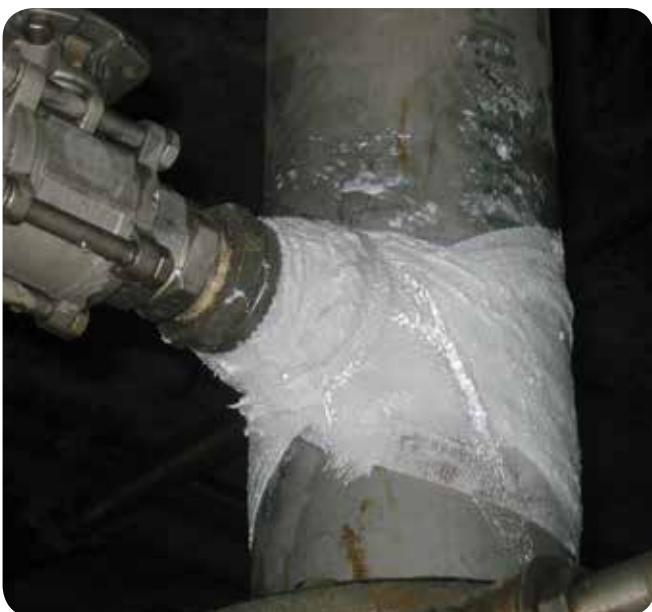
METALLIFEROUS MINES CASE STUDY

The biggest wear issues were in pipes throughout the concentrator as the slurry was very abrasive as with most mining in grinding. Although the pipes were rubber lined and, in some cases, also ceramic lined for the high wear areas, they had the occasional pipe failure of slurry leaking from either a pipe's bend (elbow), flange or valve body.

- 500mm slurry and coarse material piping and valve body leaks were contained and sealed up using Rapp-it Pipe Repair Bandages (100mm x 9m)
- 550mm Tailings pipe line leaks were successfully wrapped and sealed using Linatex rubber and wrapped with many rolls of Rapp-it Pipe Repair Bandages (100mm x 3.6m)
- Cyclone Feed spool and coarse overflow spool repairs using Rapp-it Pipe Repair Bandages (50mm x 3.6m)
- Many airline pipe pin hole leaks were detected at an early stage and wrapped and sealed using the smaller Rapp-it Pipe Repair Bandage (50mm x 3.6m).

Nearly all repairs above were able to be done on the run by using a wooden stake and driving it into the leaking hole to seal the leak. Cutting off the protruding piece of wooden stake allowed a flat surface to commence wrapping the Rapp-it Pipe Repair Bandages over the area. Once the application was completed, it set as hard as a rock and stopped the leak.
